ERTEC Environmental Systems

Case Study

Application: Stabilize Bank of Permanent Roadside Water Treatment Basin
Product: Bank Stabilization System™ **Date:** Summer 2006
Location: Lake Tahoe—Douglas County, Nevada
Customer: Logan Creek Estates General Improvement District
Engineer: JWA Consulting Engineers, Inc.
Contractor: V&C Construction, Inc.
Funded by: Tahoe Bond Act, Nevada Division of State Lands, U.S. Forest Service, Nevada Division of Environmental Protection

Project description and background

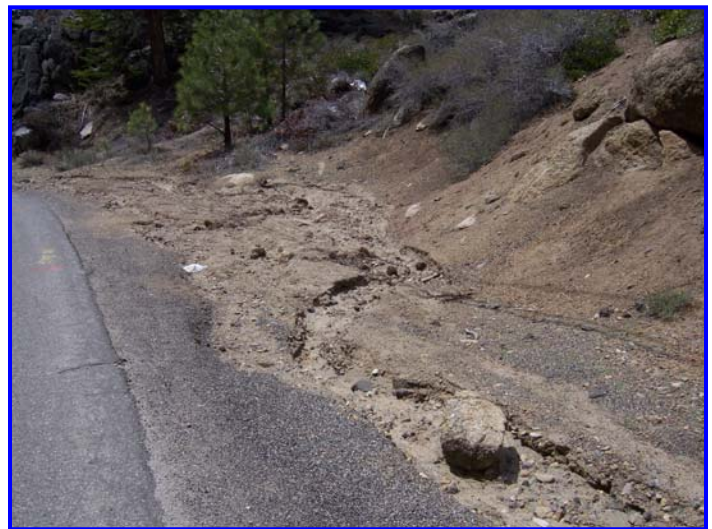
Fig 2: Pre-conditions. Location of proposed basins

In one section of the project, in order to improve drainage adjacent to the road, two small water quality treatment basins were proposed within the right-of-way. With limited room for proper basin sizing, it was necessary to create steep slopes (1:1) to attain the required basin depth and volume. The steep slopes would potentially leave the adjacent road vulnerable to erosion mechanisms such as scour, sloughing and undermining. To protect the road, ERTEC's Bank Stabilization Modules were imbedded into the slopes, completely covered and vegetated. Additionally, to enhance drainage from the water treatment basins, permeable berms were created at the downstream ends of each of the basin, by installing the BSS system and filling with drain rock.

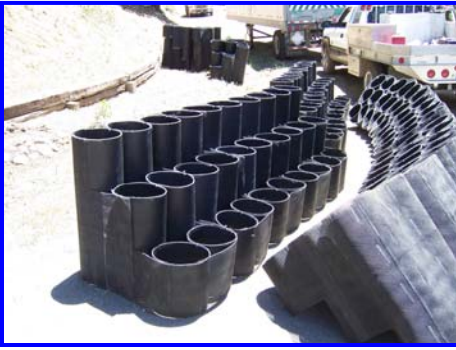
Figure 3: Section assembly

The erosion-control structures selected for the project were one-foot diameter multi-cylinder modules (ERTEC Environmental Systems) of high-density polyethylene (HDPE). For Bank Protection—each set consisted of one 1', one 2', and one 3' length cylinders fastened into a staircase buttress design. Two sets were fastened to each other to increase structural integrity, forming a module two feet wide. To increase soil retention, a 200-micron AOS filter fabric was layered within the cylinder walls. Initial soil excavation provided a level footing to set the modules. The perimeter surfaces and bottom of the modules were wrapped with a non-woven filter fabric to provide additional soil retention. The Berm system structure was similar but contained an additional 4' cylinder. The Bank system was filled with sand slurry pumped in with a concrete pump. The two Berm systems were filled with drain rock. As installation was completed, crews back-filled the modules and voids with loose soil and compacted it. As a last step, crews shaped the two water treatment basins, installed re-vegetation and erosion control blankets throughout the basins.

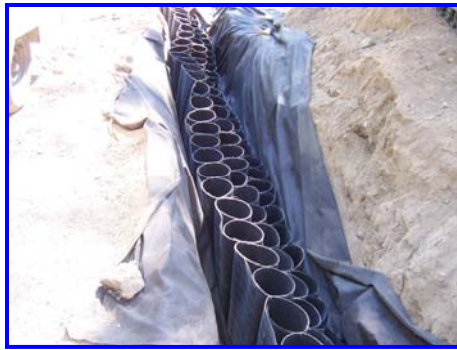
Figure 4: Section placement—post trenching—bank protection

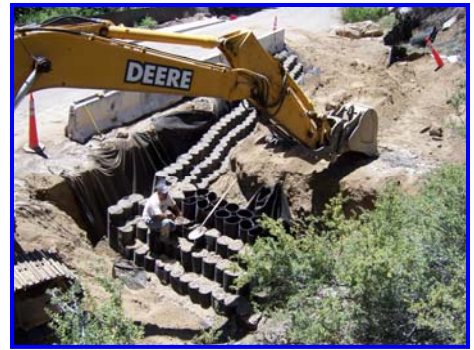
Figure 4: Filling of inter-basin berm trenching

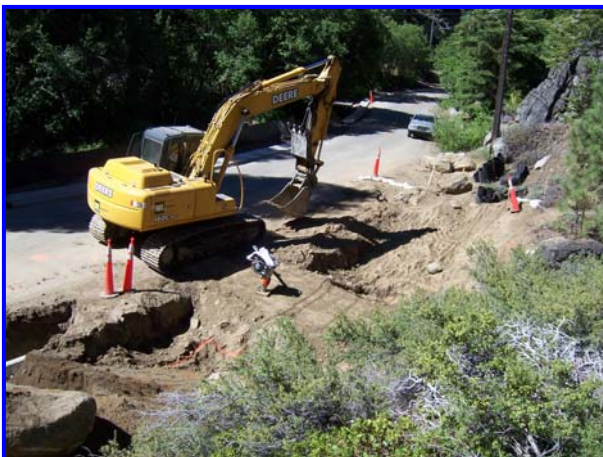
Figure 5: During backfill and basin forming

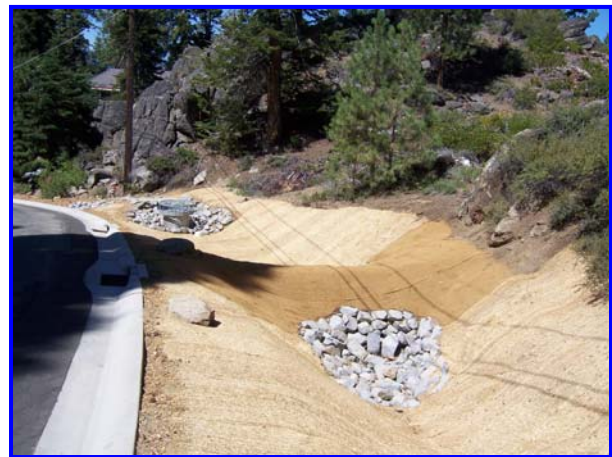
Figure 6: 2 months after installation
