# ERTEC Environmental Systems

## Case Study

**Application:** Bio-Technical River Bank Stabilization  
**Product:** Bank Stabilization System™  
**Location:** Decker Island Levee Bank Stabilization Project  
**Customer:** State of California Department of Water Resources  
Delta Levees Program  
**Installation:** October 2002

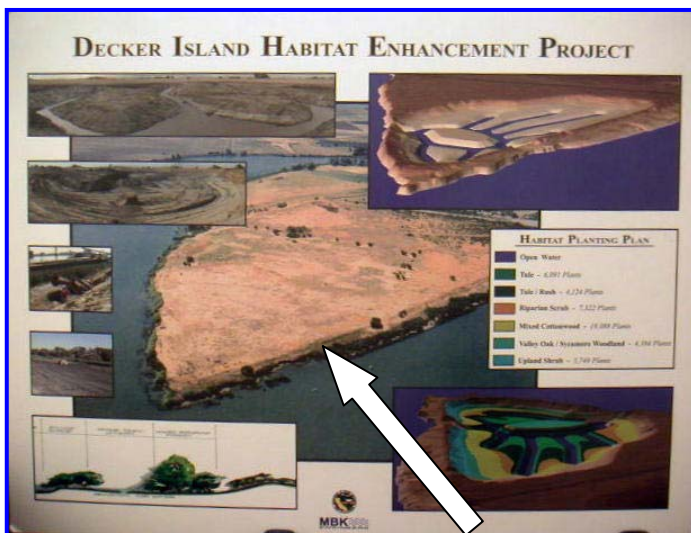
Figure 1: Location of ERTEC project on Decker Island

Exposed bank (see white arrow in Figure 1) – at northwest tip of Decker Island on Sacramento River – original rock-retaining berm washed away. Heavy, swirling currents, heavy winds and large pieces of driftwood serve to scour shoreline away at a rate of 5 ft per year.

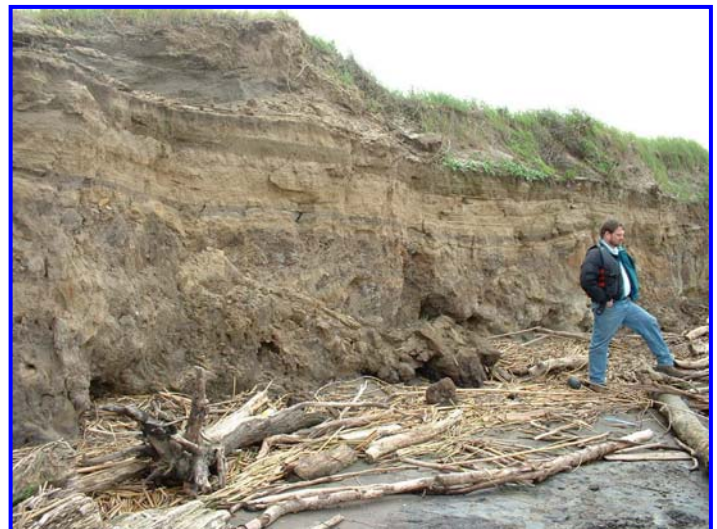
Figure 2: Pre-project site conditions

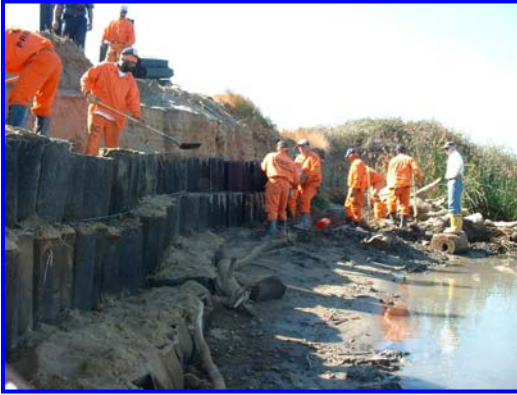
Figure 3: Installation in progress

The erosion-control structures selected for the project were one-foot diameter polygonal modules (ERTEC Environmental Systems) of high-density polyethylene (HDPE). Each set consisted of two 2', one 4', and one 6' length fastened into a stair-case buttress design. Two sets were fastened to each other to increase structural integrity, forming a module two feet wide. To increase soil retention, a 300-micron AOS filter fabric was layered between the module walls. Using labor crews from the Department of Corrections under the supervision of a fire captain from the Department of Forestry and Fire Protection, the project commenced under compatible tide and construction window conditions. Initial clearing of debris and soil excavation provided a level footing to set the modules. The perimeter surfaces and bottom of the modules were wrapped with heavy-duty filter fabric to provide additional soil retention and wave attenuation. The sets were then anchored with stainless steel cable and "duckbills" that were driven 3-5 feet into the face of the bluff. Cables were also wrapped and clamped around adjacent modules. As installation was completed, crews back-filled the modules and voids with loose soil and compacted it with water to create a rigid, but semi-permeable structure. As a last step, crews recessed the top of the bank prior to re-vegetating it with plugs of native grass and willows in and around the modules. Post-storm season conditions 2003, 2004 and 2005 indicate the structure held up well against heavy debris and native grasses and willows are growing profusely creating complex habitat. Flood conditions (high flows, tides and wind) will ultimately determine the utility of this innovative project.

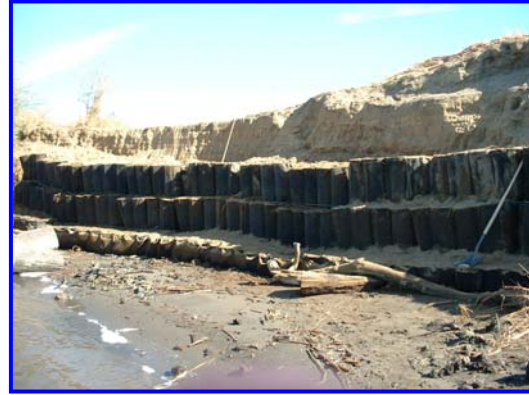
Figure 4: Installation complete

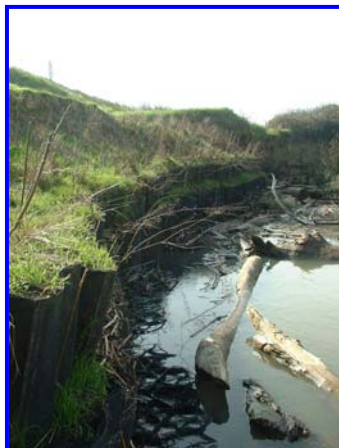
Figure 5: 2 months after install

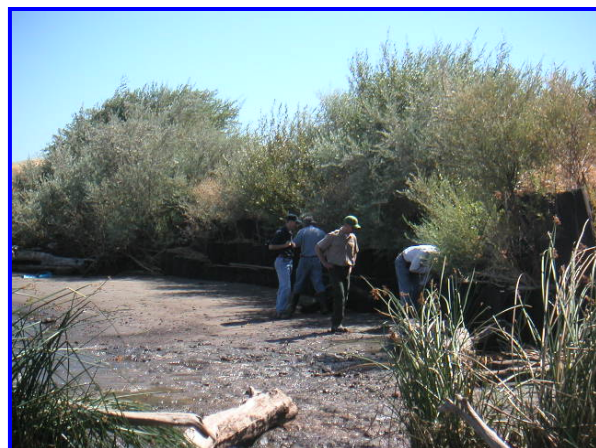
After three storm seasons – the bank has stabilized. Profuse vegetation is established and riparian habitat is enhanced. Erosion is significantly reduced.

Figure 6: 2 years after installation
